# Manhole Inspection Summary

Manhole # S17GG1008MH

**Location** Address: **2404 SHIRLEY AVE**

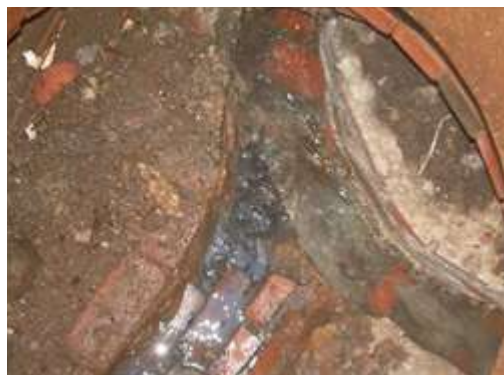
Top View

Evidence of surcharge - Bench debris.  
Channel debris.

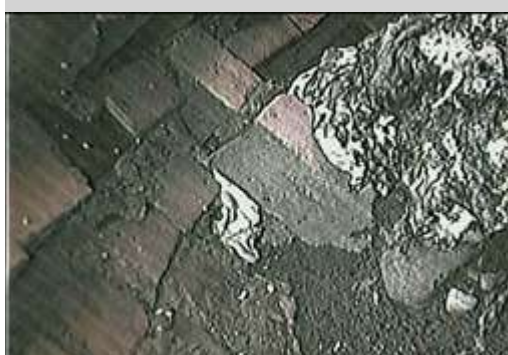
Brick supports

Comments **This MH has interior brick supports - it may not be stucturally sound.**

Calcification and missing bricks from the  
Barrel.

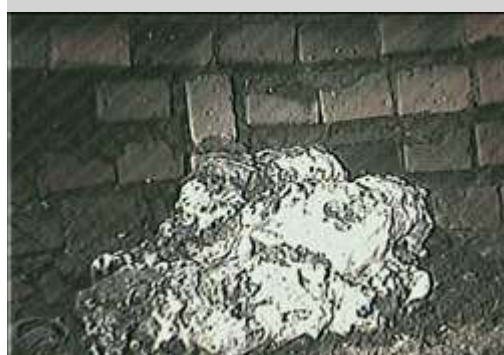
Defect

Barrel deterioration and infiltration.

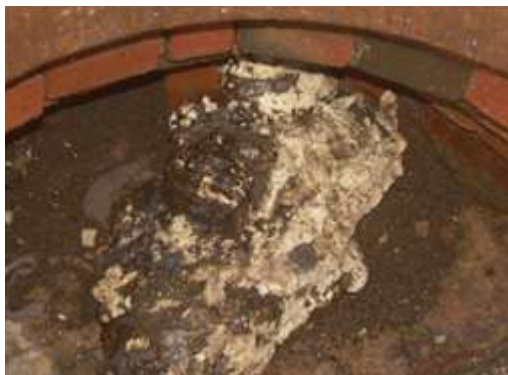
Defect

Grease or Calcification.

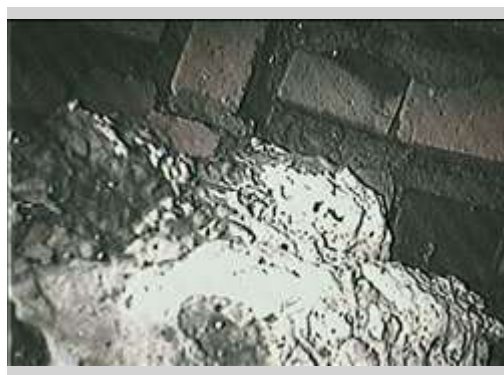
Defect

Barrel deterioration and infiltration.

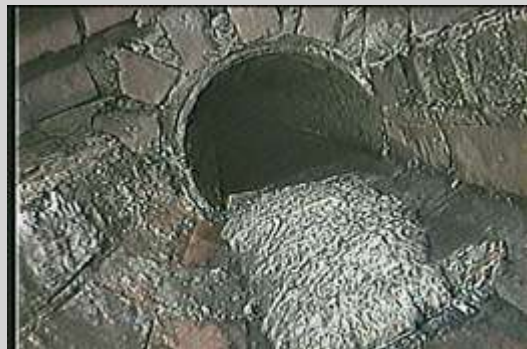
Pipe In @ 8 O'Clock

Deposits: ☐ None ☐ Mud ☐ Sludge ☒ **Debris** ☒ **Grease**

Infiltration: **Evidence**
